CERTIFICATE OF LOCATION OF GOVERNMENT CORNER

North Quarter Corner of Section 23, Township 36, Range 29
4TH Principal Meridian, State of Minnesota, County of BENTON

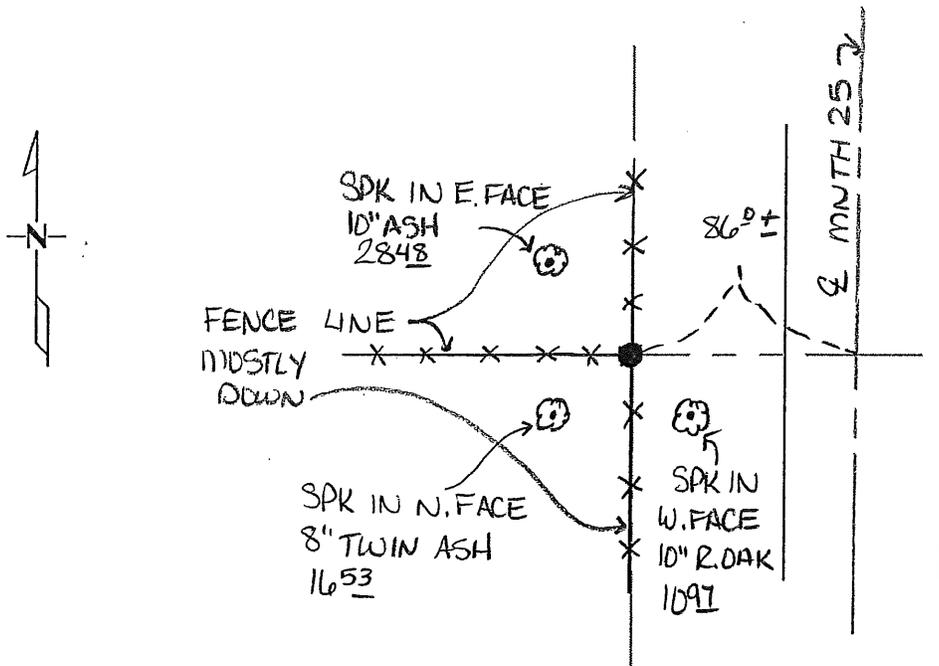
At the corner location shown on the sketch:

On 5/20/2002 placed a cast iron monument, based on MnDOT alignment notes
DATE
for TH25, which fits the intersection of fences N/S/W

Ties that are found and in good condition are noted as 'existing'. New tree and power pole ties are to the head of a nail with a brass disk marked "Corner Tie".

On May 13, 2002 Westwood Professional Services, Inc. searched for the corner and dug by hand in the area of the corner location as noted on old MnDOT alignment maps (showing the corner as 87.00 feet west of the centerline). We found down and buried fence lines to the north/south and west. We established the corner location by recreating the old MnDOT alignment from the maps and found that the location fell at the intersection of the fence lines.

We found no evidence of the pipe or the tie trees noted in 1972 and question if the information is for this corner. We measured 5341.36 feet between the NW and NE corners of Section 23, which agrees within 2 feet of the original GLO measurements. The reestablished location falls 25.98 feet south and 75.60 feet west of the lost position. MnDOT plans show an iron at the center of Section 14—using this reestablished 1/4 corner the computed center of Section 14 falls 36.7 feet west of MnDOT's found center. This would tend to support the lost position. However, the MnDOT plans also show a center of Section 23 and the south quarter corner of Section 23 based on occupation lines. Using reestablished corner position the north/south quarter line of Section 23 falls 2.9 feet east of the MnDOT center of Section 23, which supports the reestablished position.
